**DES MOINES SOUTH POND/
DRAINAGE AREA
SOURCE CONTROL OPERABLE UNIT
(OPERABLE UNIT NO. 4)
BUILDING SAMPLING, ANALYSES,
AND ENGINEERING EVALUATION
REPORT**

**DICO INC.
200 Southwest 16th Street
Des Moines, Iowa 50305**

ECKENFELDER INC.

August 1992

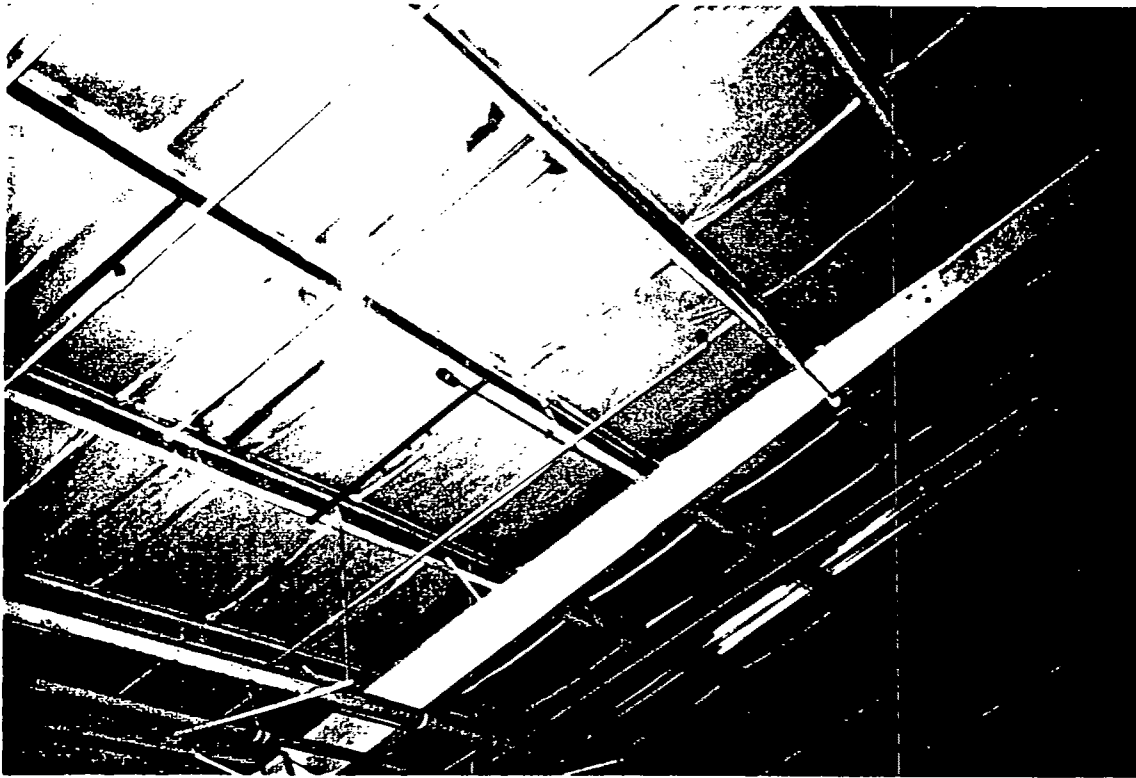
Building No. 2 (Sample Building D). As discussed previously, the northwest quadrant was constructed first in this building. Insulation exists in the ceiling but not in the walls which are constructed of block and some sheet metal. Ceiling insulation is covered with a mesh fabric reinforced aluminum foil panel and the foil is covered with a paper-type laminate material. The integrity of the foil panel appears to be good within most of the area. A few minor tears in the panels exist, but are not greater than 3 to 4 inches in any dimension. Photograph 1, Appendix A, depicts the area.

1 - BUILDING NO. 2, NORTHWEST QUADRANT CEILING INSULATION (TYPICAL)

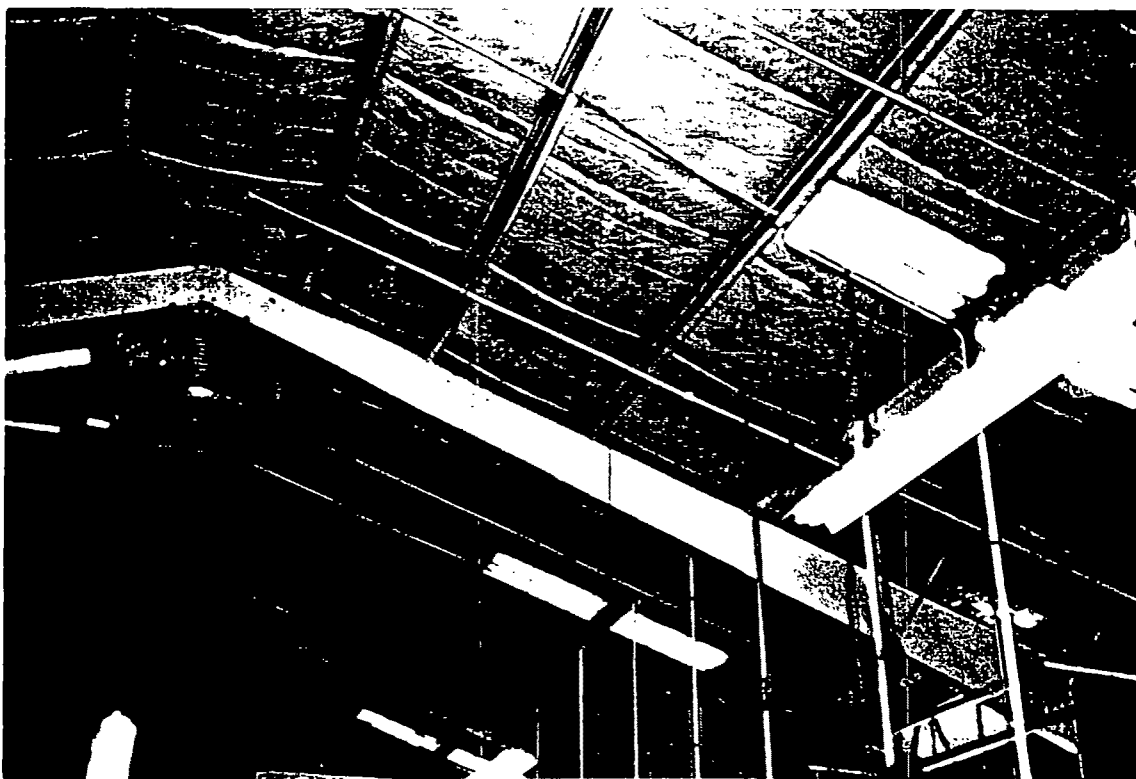
The northeast quadrant of the building was constructed at a later date than the previously described area. The panels covering the ceiling insulation consist of an aluminum foil material with a paper laminate, but no mesh fabric reinforcement as was typical of the previously described area of this building. Tears in the panel appear somewhat more frequently than in the northwest quadrant, but no greater than approximately 10 percent of the panel areas (between beams and joists) contain small (less than 4 inch) tears. No wall insulation is apparent. Photograph 2, Appendix A, depicts the area in January 1992.

2 - BUILDING NO. 2, NORTHEAST QUADRANT CEILING INSULATION (TYPICAL)

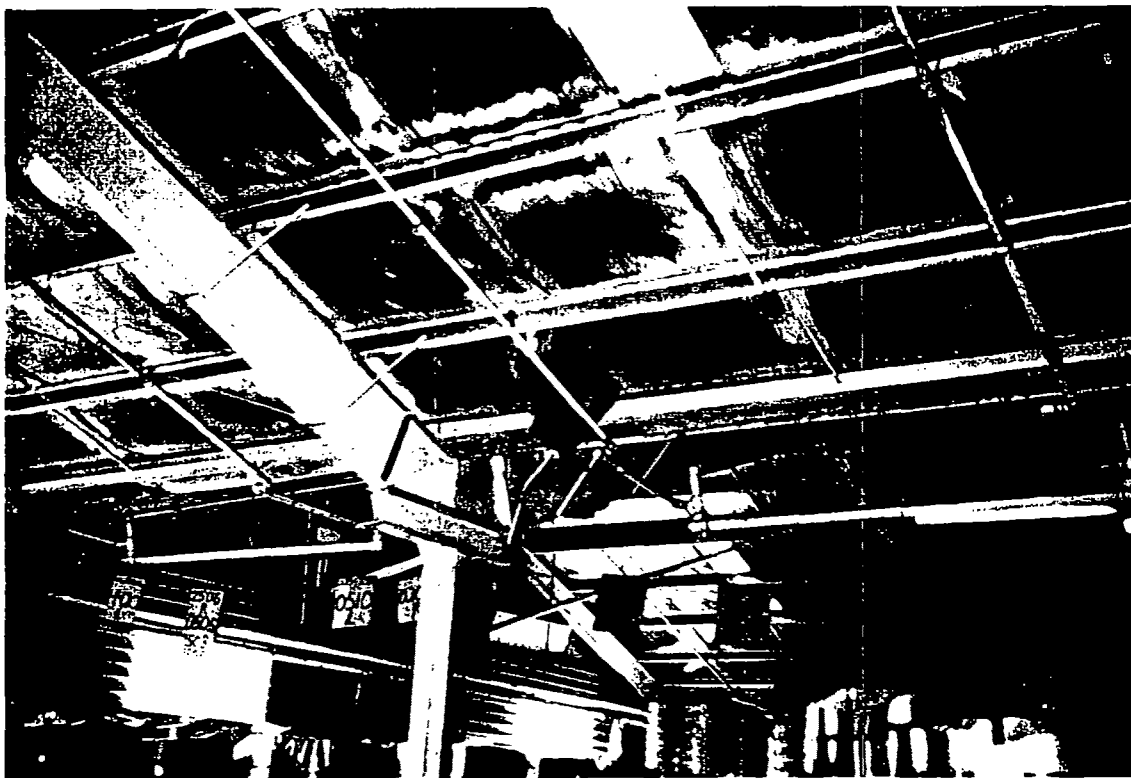
The south section of this building was constructed after the two sections discussed above. The panel covering the ceiling insulation consists of a shiny aluminum foil with fabric reinforcement. No paper-like finish exists. A few areas contain large (greater than one square foot) tears and approximately 20 percent of the panel areas contain small tears. The western section of the area is more intact than the eastern section. An area in the north wall contains some exposed insulation that is a pink color rather than the beige color typical in the ceiling. Photographs 3, 4, and 5, Appendix A, depict the area in January 1992.

3 - BUILDING NO 2, SOUTHEAST AREA CEILING - TORN INSULATION AREA

Exposed insulation ceiling repairs for the most part would involve placing heavy adhesive tape over small tears and holes. A few panels of ceiling insulation (primarily in Building 4) have been damaged more extensively so removal and replacement may be appropriate. Proper off site disposal of any waste PCB containing insulation would be required, however, the quantity of waste material is expected to be quite small and would be minimized. Workers who conduct the repairs would have to be properly trained in health and safety.

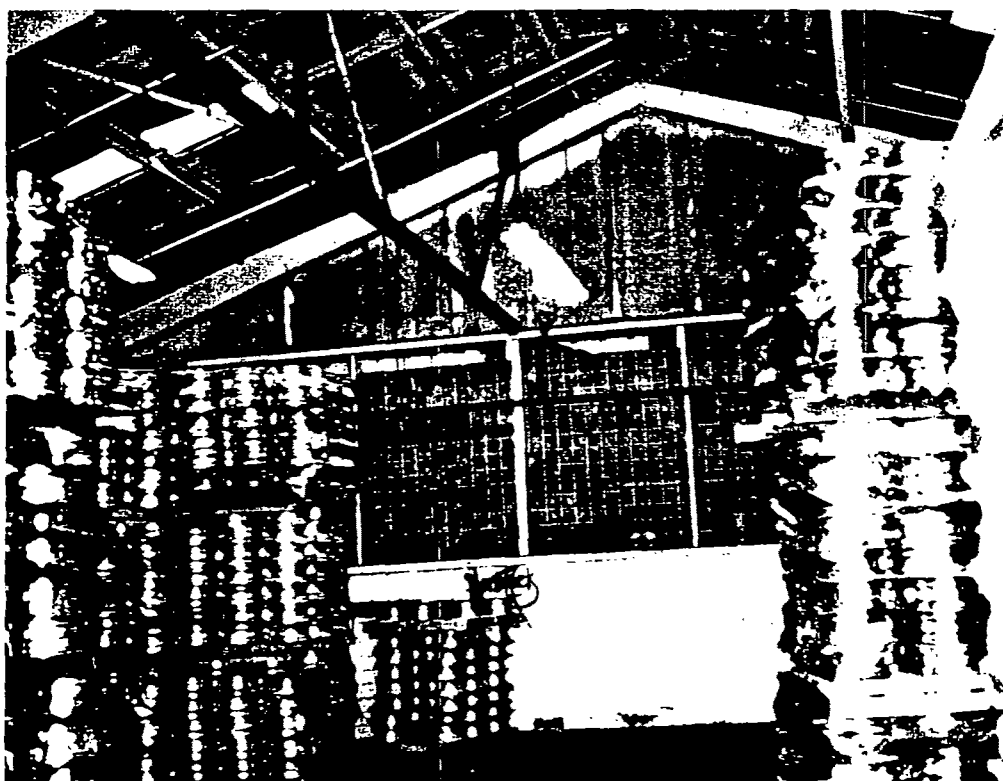
4 - BUILDING NO 2, INSULATION INSTALLED IN NORTH WALL OF SOUTH ROOM

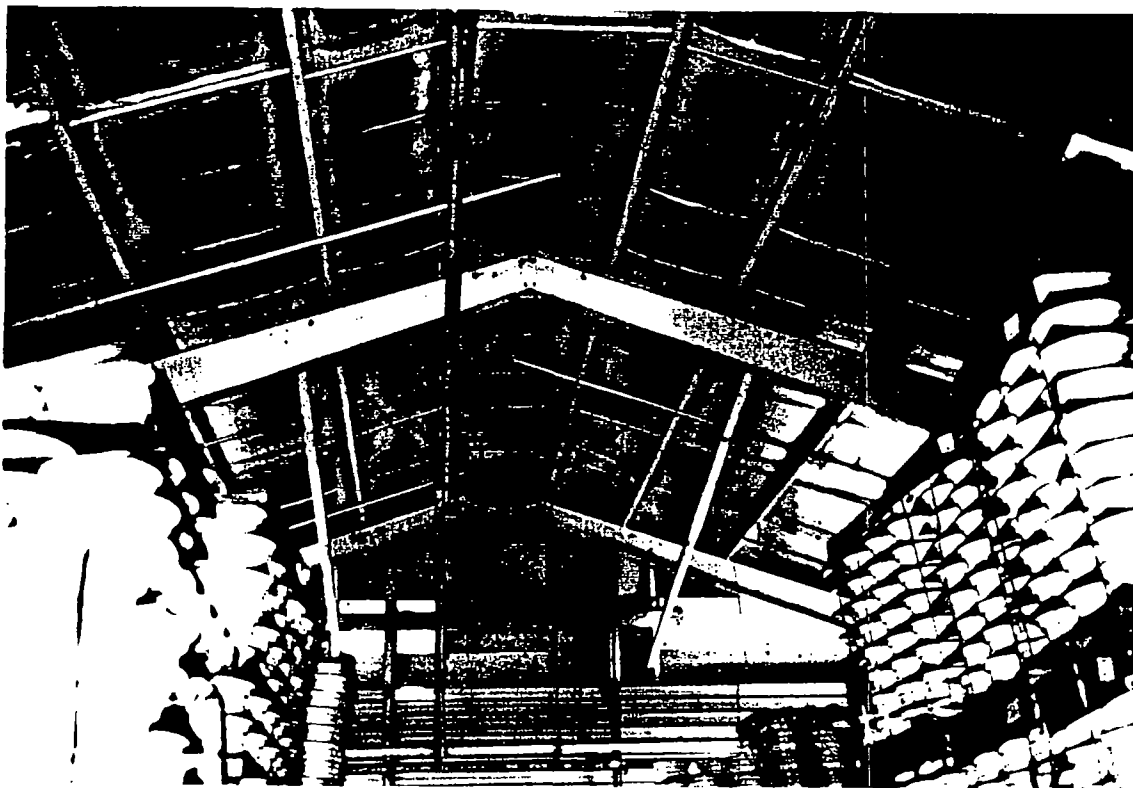
5 - BUILDING NO 2, SOUTHWEST AREA CEILING INSULATION (TYPICAL)

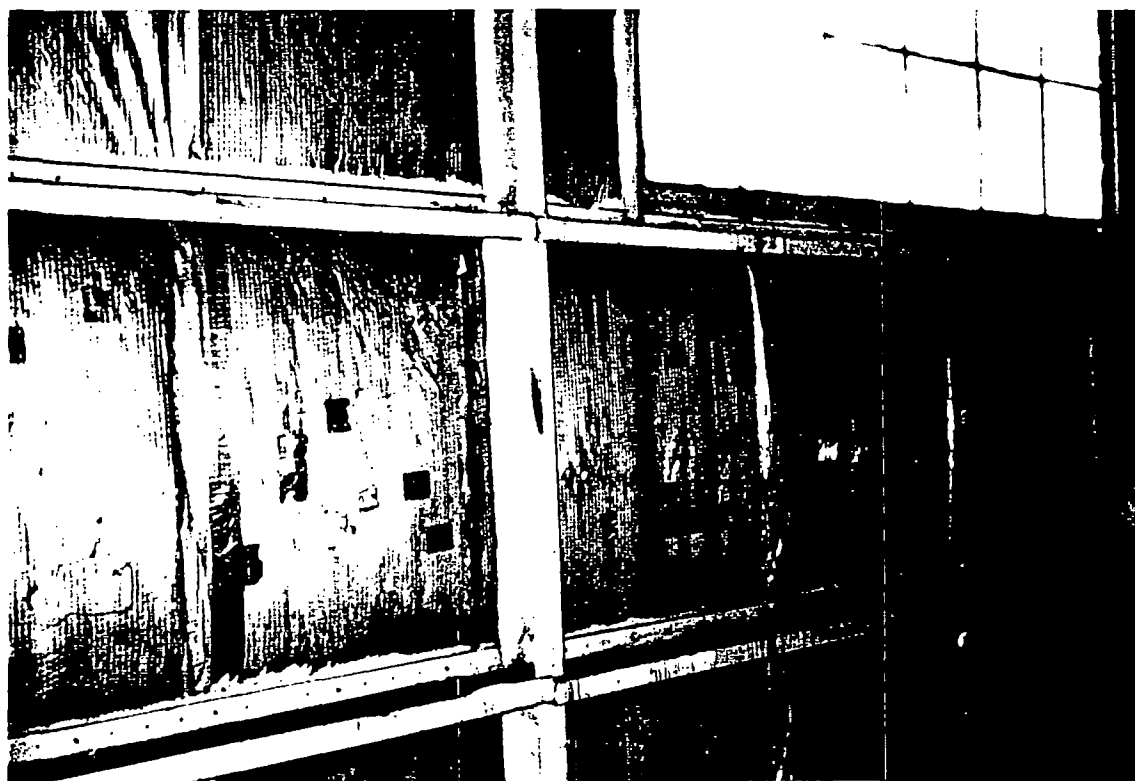
6 - WALKWAY BETWEEN BLDG. 2 AND BLDG. 3, WALL INSULATION (TYPICAL)

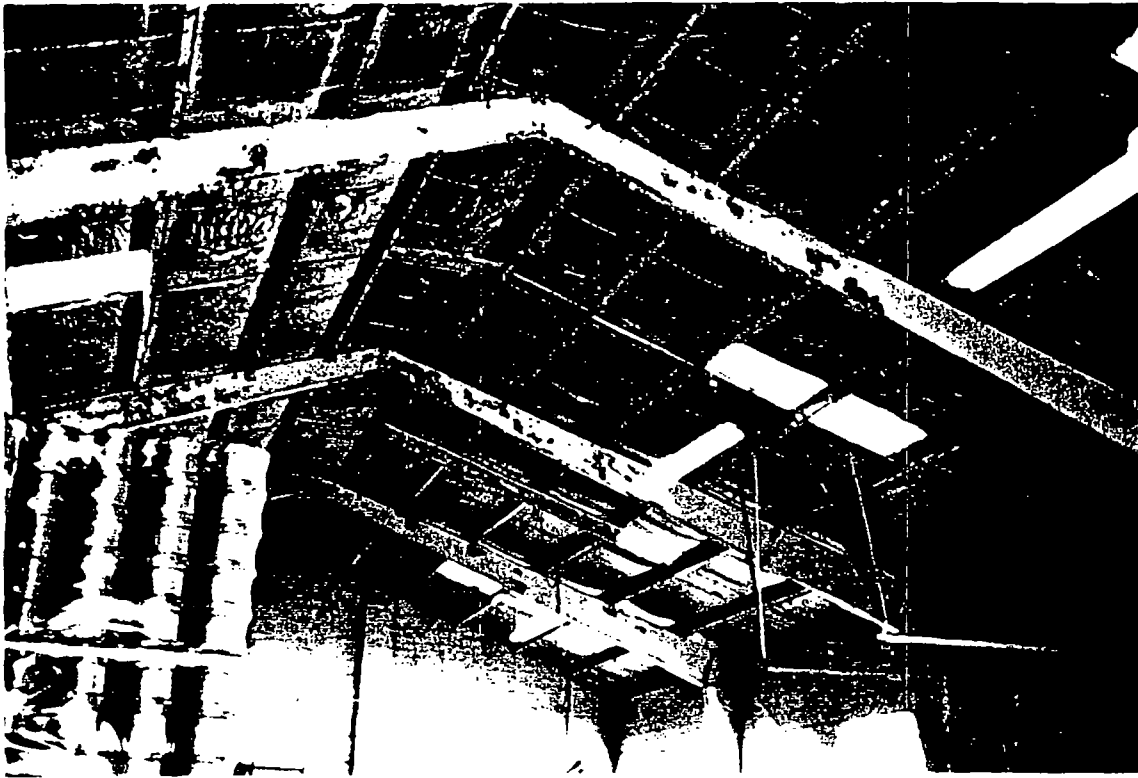
The northern room has an open ceiling and heat is provided by overhead steam fed fans. Much of the painting on the structural steel is chipped and loose. The approximate ceiling height ranges from 18 feet above the floor in the lower portions of the spans to 25 feet above the floor at the peaks of the spans. The partition separating the northern and the southern room contains some cracks and openings. All floors in the building are concrete slabs on grade.

7 - BUILDING NO 3, NORTH ROOM CEILING INSULATION AND CHIPPED PAINT (TYPICAL)

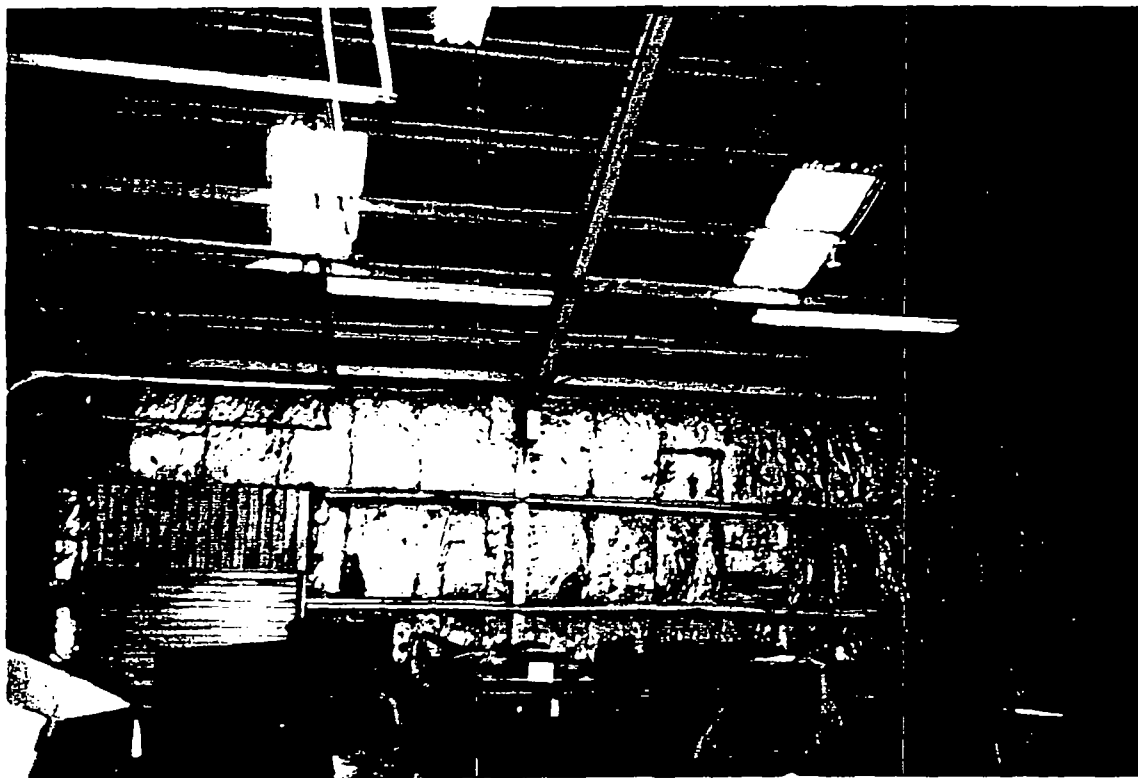
8 - BUILDING NO 3, NORTH ROOM WALL INSULATION ON SOUTH WALL (TYPICAL)

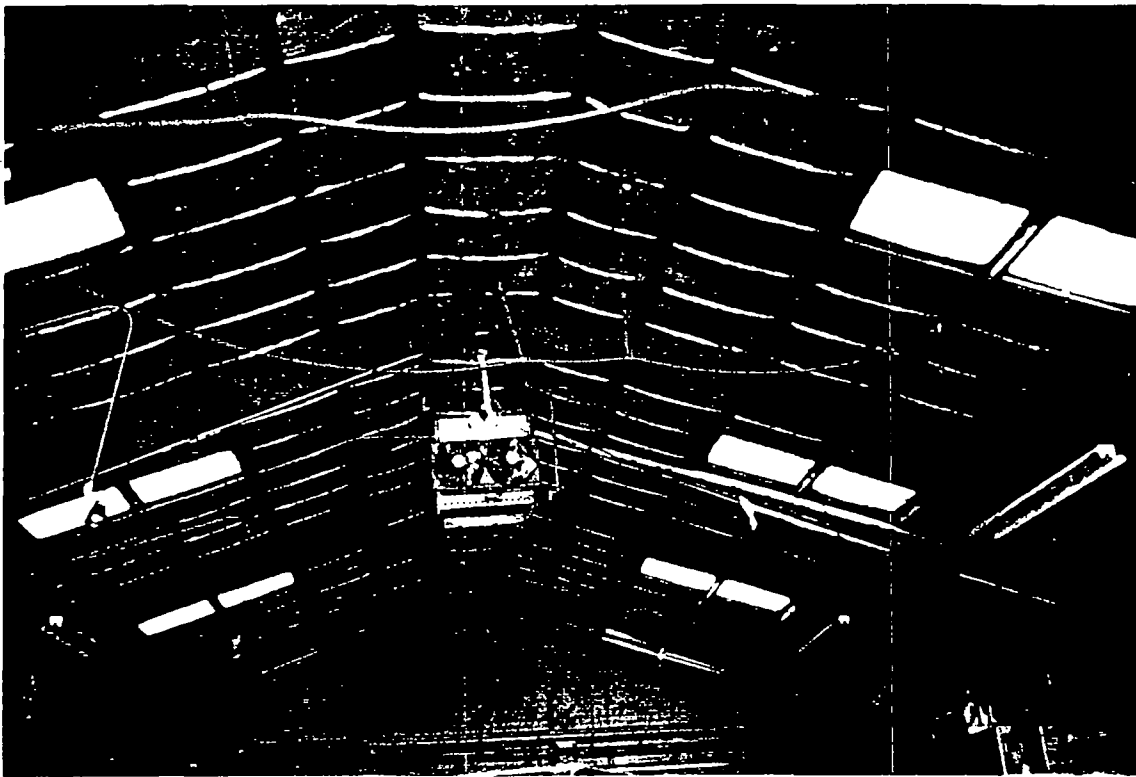
9 - BUILDING NO 3, SOUTH ROOM CEILING INSULATION (TYPICAL)

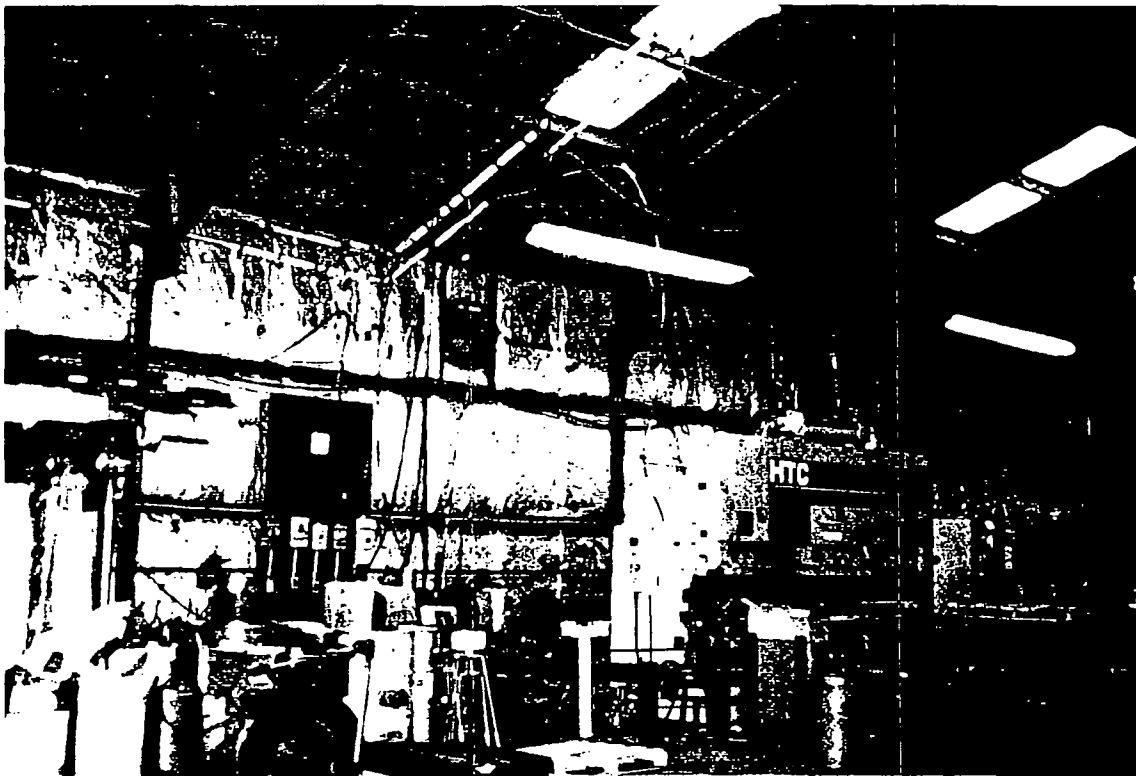
10 - BUILDING NO 3, SOUTH ROOM SOUTH WALL INSULATION (TYPICAL)

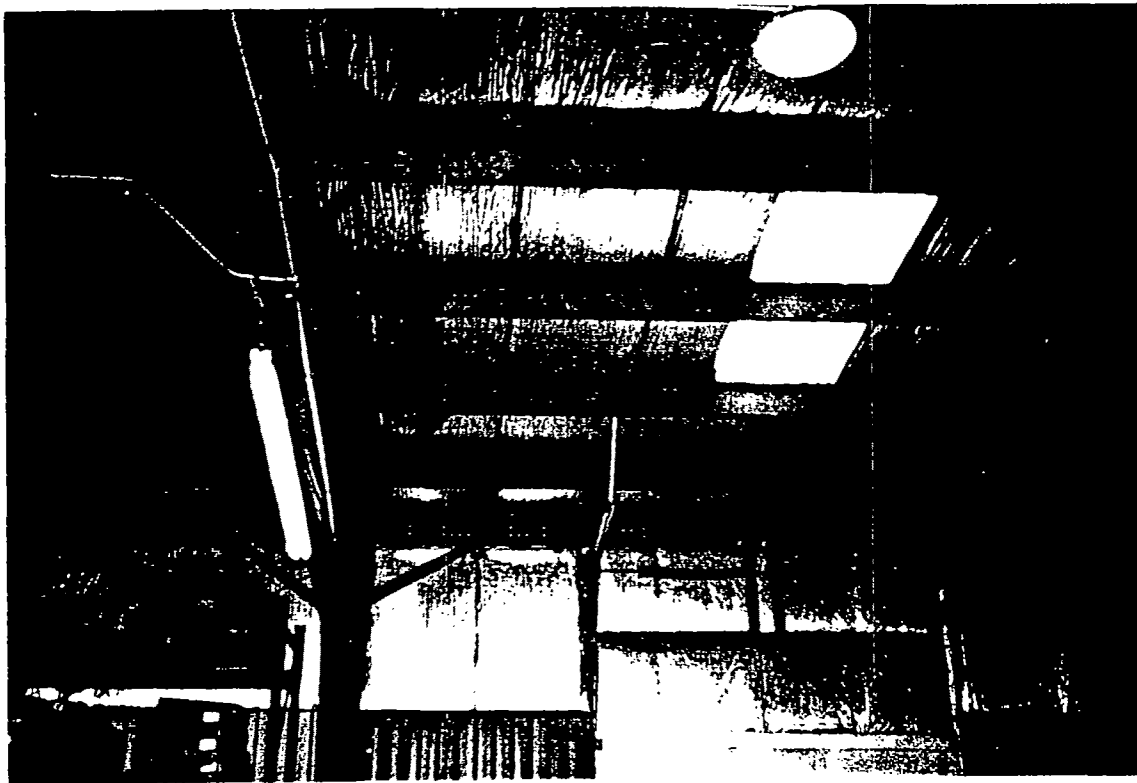
The western annex of this building was constructed after the north and south portions. Foil covered insulation exists on the upper portions of the north, west, and south walls as well as on the ceiling. The wall insulation is intact except for four locations where the insulation has been damaged. Large tears exist at these four

locations. The majority of the ceiling insulation appears to be intact with very few small tears. Photographs 11 and 12, Appendix A, depict this room in January 1992.

11 - BUILDING NO 3, WEST ANNEX, SOUTH WALL AND CEILING INSULATION (TYPICAL)

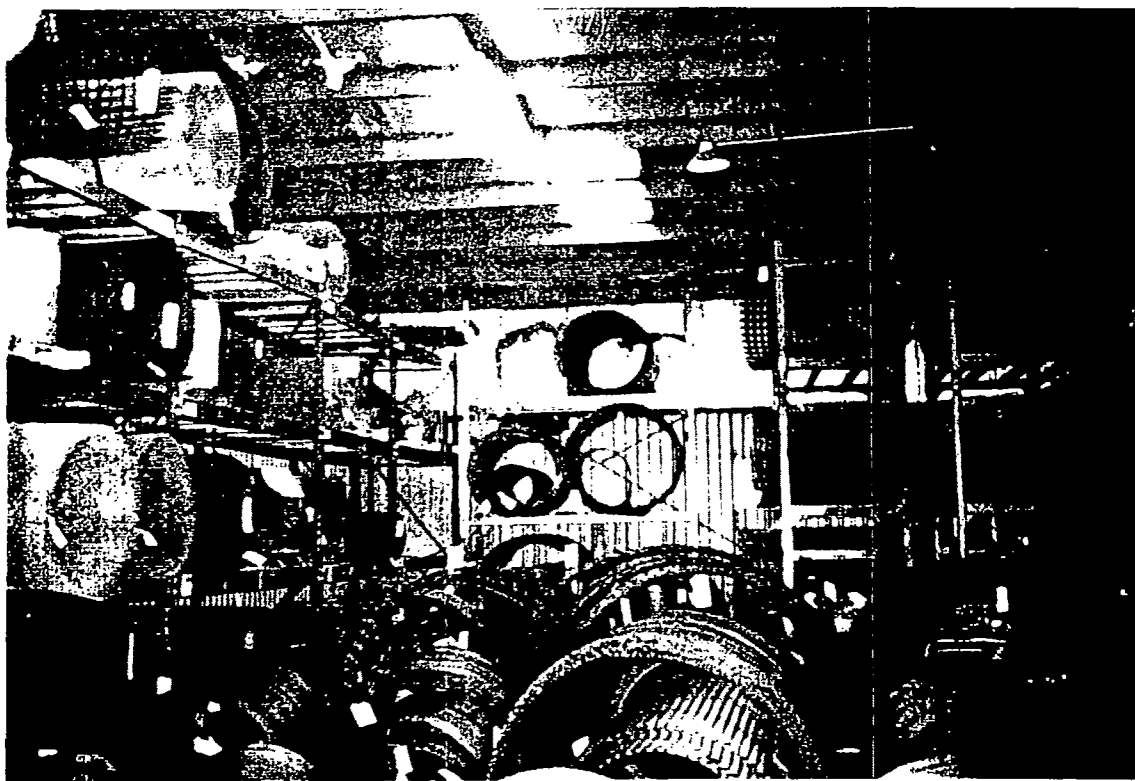
12 - BUILDING NO 3, WEST ANNEX, NORTH WALL WITH INSULATION DAMAGE DUE TO EQUIPMENT IN THE AREA

Wall insulation extends from floor to ceiling in some areas, and partially covers walls in other areas. Wall insulation would be covered with thin sheet metal panels. Minor electrical and mechanical equipment relocations would be required to
